**FINAL REPORT ON TAIL STRIKE INVOLVING AN  
AIRBUS A330-343 AIRCRAFT (REG: 9V-SSI) AT  
YANGON INTERNATIONAL AIRPORT,  
ON 25 NOVEMBER 2019**

**Aircraft Accident Investigation Bureau  
Ministry of Transport and Communications  
Myanmar**

**9 November 2021**

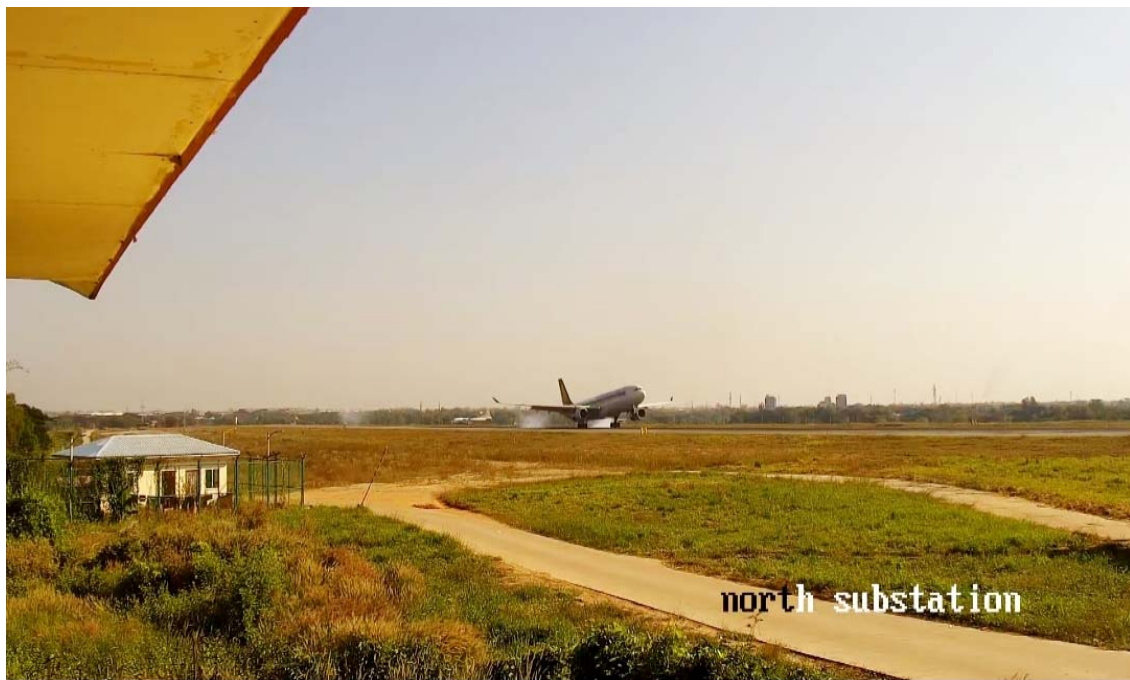
A surveillance camera located at a lookout hut in the vicinity of the runway recorded the event landing. Figures (2) and (3) shows the sequence of the tail strike.

**Figure (2) Main landing gears touched down on the runway**

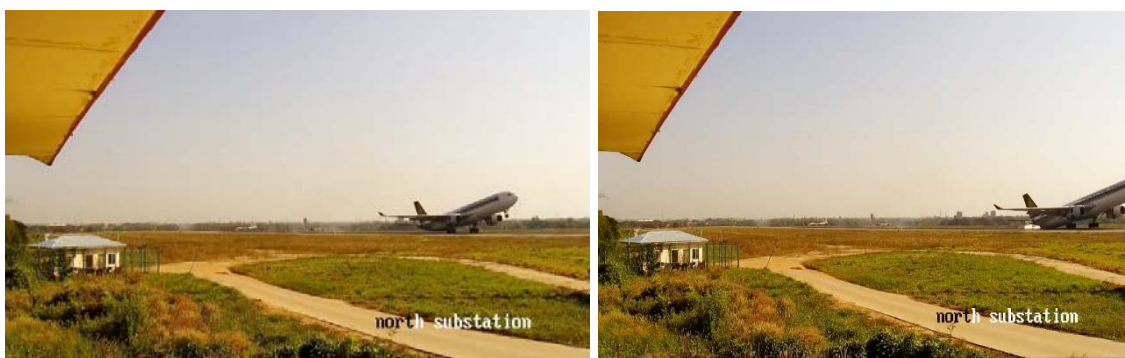
**Figure (3) Photos showing the tail strike on the runway**

The difference in understanding of the phrase “hold the attitude” appears to have contributed to the PF providing additional pitch up inputs. The net effect of the PF’s cumulative pitch up inputs led to the aircraft’s pitch attitude reaching a maximum value of 10.7 degrees which was the likely instance where the tail strike occurred.

During the landing, the pitch up inputs by the PF caused the aircraft to reach a maximum pitch angle of 10.7 degrees, resulting in the tail strike.

- (1) The operator to ensure that its instructor pilots have greater urgency to take over control of the aircraft, especially during landing.
- (2) The operator to ensure that pilots performing pilot monitoring duties to use standard phraseology such as “PITCH PITCH” when the pitch angle of the aircraft exceeds 7.5 degrees during landing, as required by its procedures.

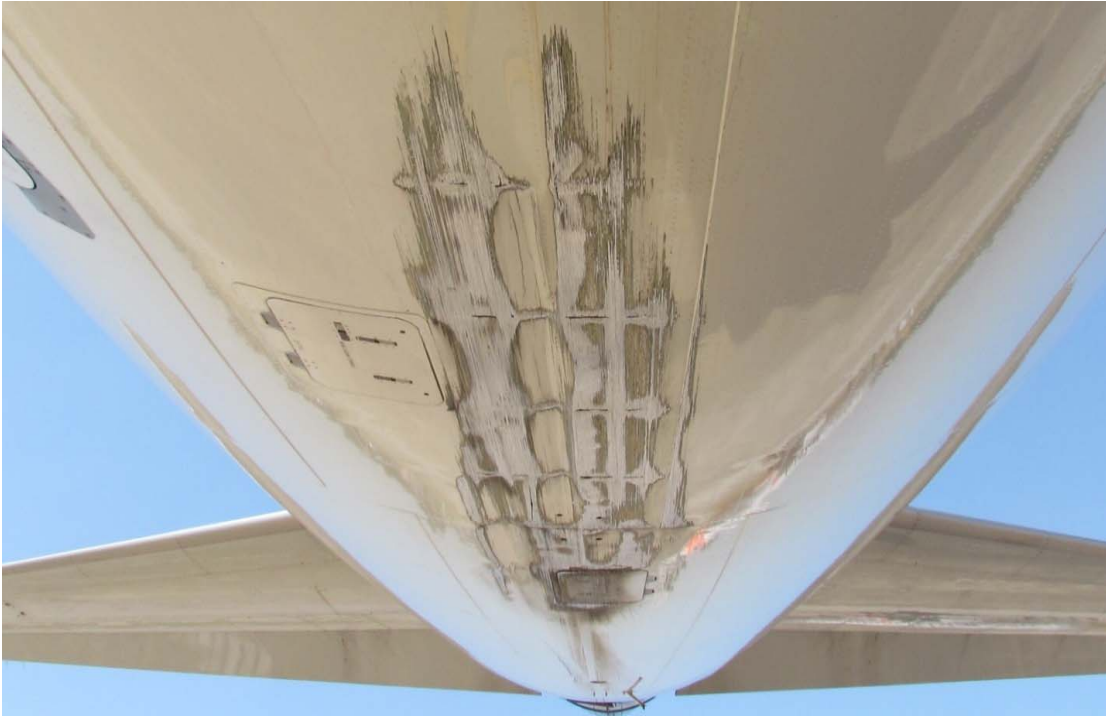
- (a) Fuselage Lower Skin between frames 68 and 73 in the tail section were dented, scratched and torn
- (b) Fuselage frames between frames 60 and 73 in the tail section were bent and scratched

**Figure (4) Scrape marks on aircraft tail section**

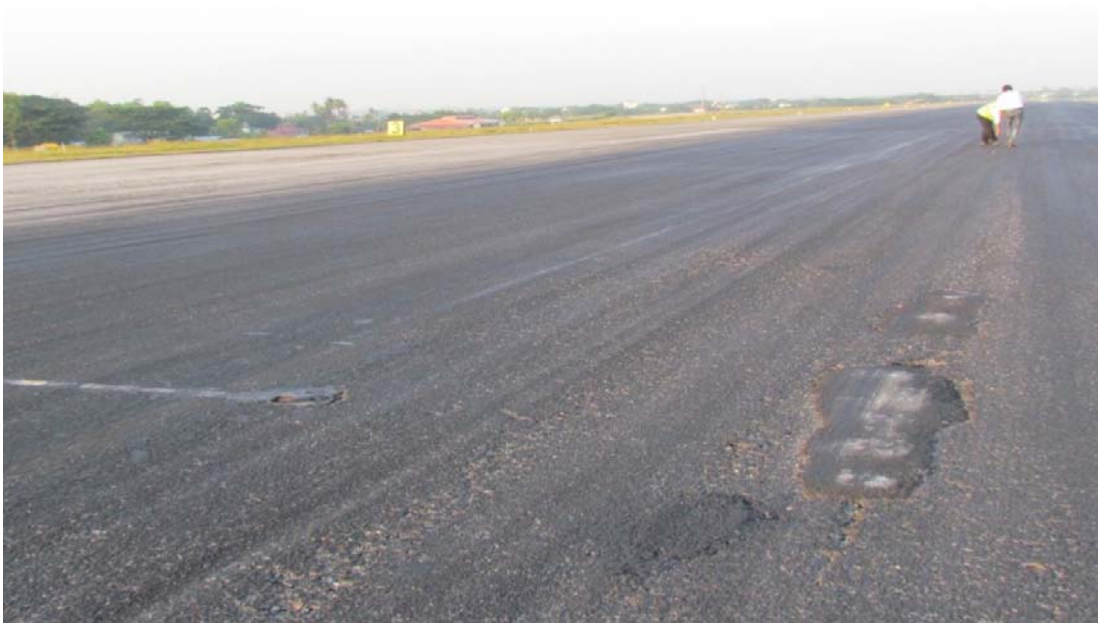
Scrape marks were found on the surface of the runway.

**Figure (5) Scrape marks on the runway**

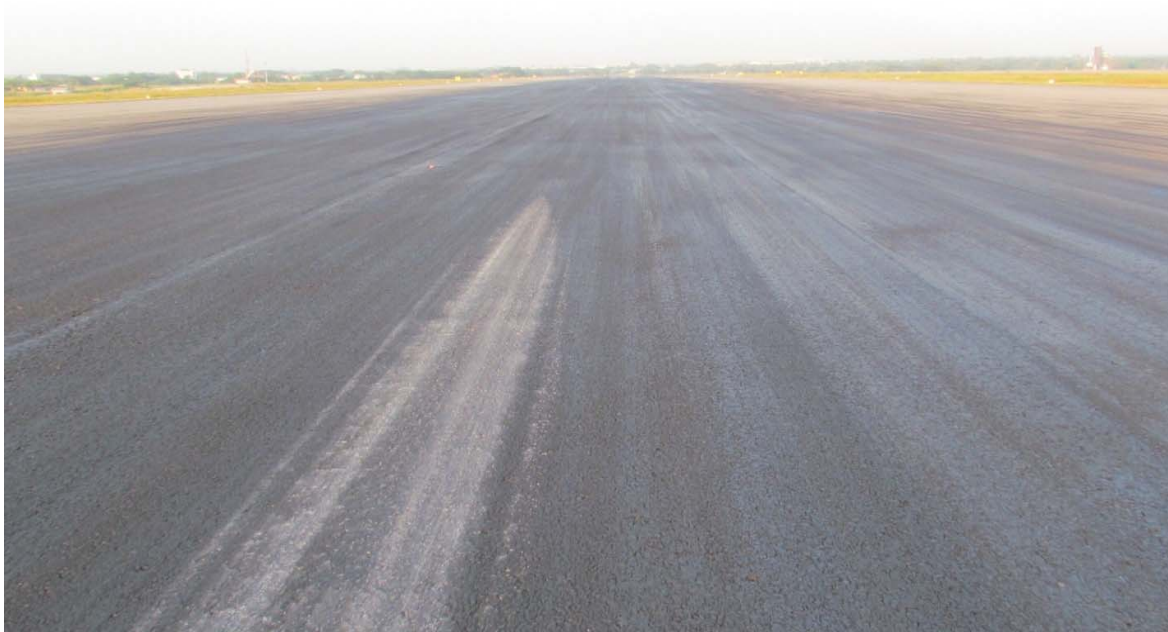
**Figure (6) Tail strike marks on the runway**

The coordinates of serious incident site were Latitude N 16°54' 42", Longitude E 96°08' 26". The tail strike marking on the runway was 56.1m long and 0.7m wide. The tail strike could be seen clearly at the 1.5m of runway centerline and about 3,000ft from the Runway 21 threshold near the Distance Marker Board 8/3.
